# Prediction of the long-term corrosion rate of copper alloy objects

K. Kreislova\* and H. Geiplova

In this paper, actual corrosion studies of two long-term exposed objects – a bronze statue of John of Nepomuk from Charles Bridge and the copper roof of Queen Ann's Summer Palace, are presented. Both these objects are exposed to Prague's urban atmosphere for more than 300 years. The predicted and measured corrosion rates are compared for these cultural objects. During their exposure the corrosion rates changed as the result of changing corrosivity of atmosphere in the Prague centre.

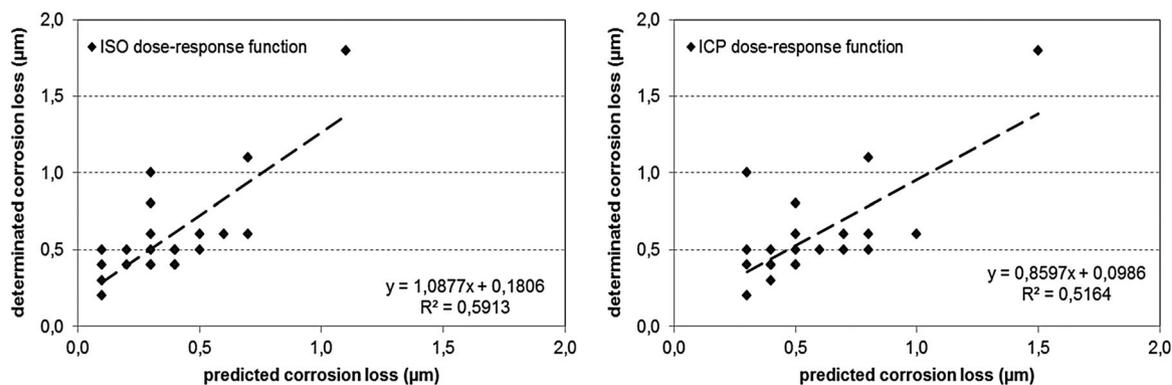
Figure 1. Comparison of determined and predicted corrosion mass loss of copper.

Comparisons of determined and predicted yearly corrosion mass loss of copper are given in Figure 1. All prediction models included some uncertainty for dose-response functions – the best fitting values for copper corrosion in the period 2011–12 within the framework of the UN ECE ICP *Effect on Material* programme was estimated for the ISO equation. All prediction models were derived from database obtaining mainly the corrosion and environmental data from period when the  $\text{SO}_2$  was more dominant factor of the atmospheric corrosion. The  $R^2$  values are relative low for actual data. The comparison of

prediction models for bronze alloy is very similar, but the  $R^2$  value is higher.

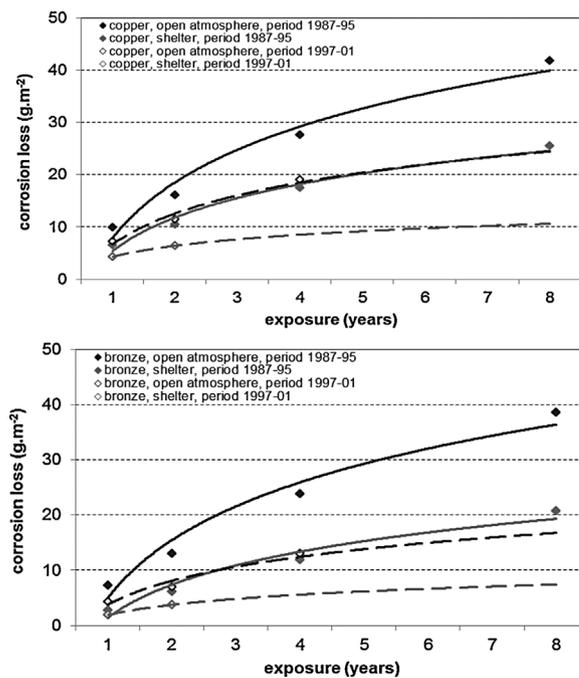
Figure 2. Corrosion mass loss of copper and bronze in open and sheltered atmospheric exposure.

The corrosion mass losses of copper and bronze in sheltered locations protected against direct precipitation are lower than those estimated in open atmospheres (Figure 2). There are many such surfaces on actual objects/statues.

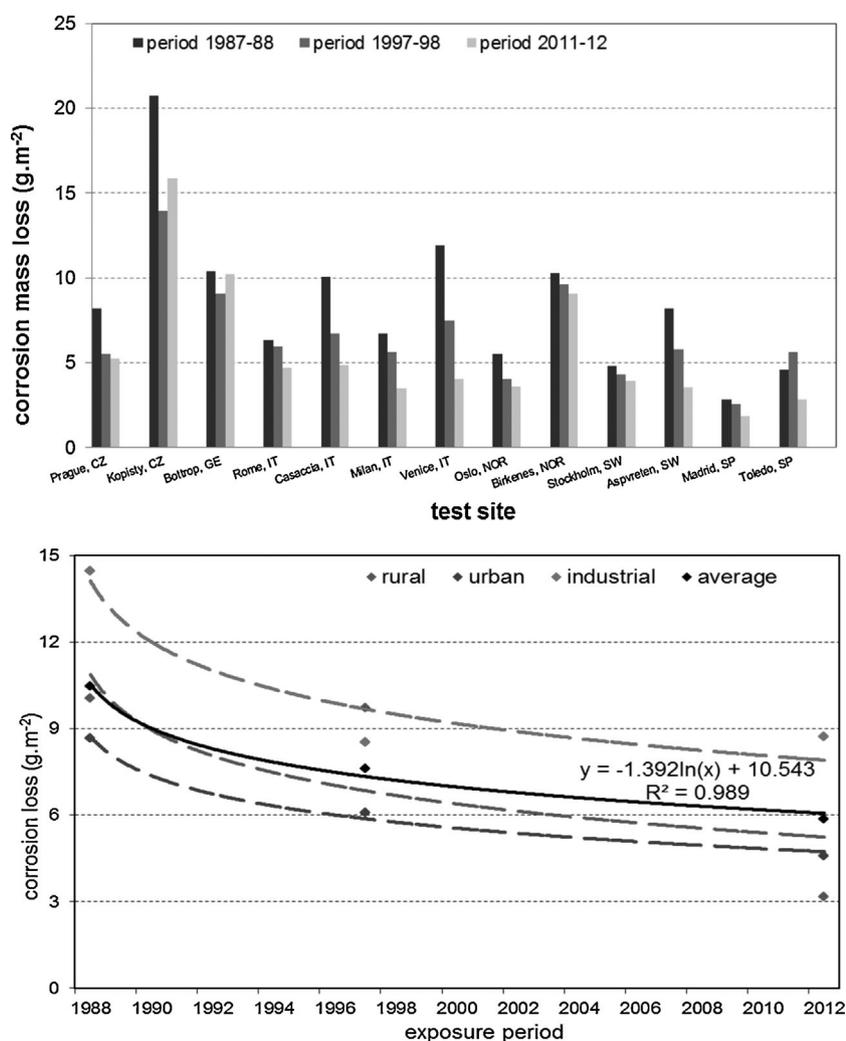
**Figure 3.** Change in corrosion mass loss of copper over various periods in Europe.

A comparison of yearly copper mass loss at the European test sites in these periods is given in Figure 3. The trend of decreasing yearly copper corrosion mass loss is not as significant as in the other metals (carbon steel, zinc).

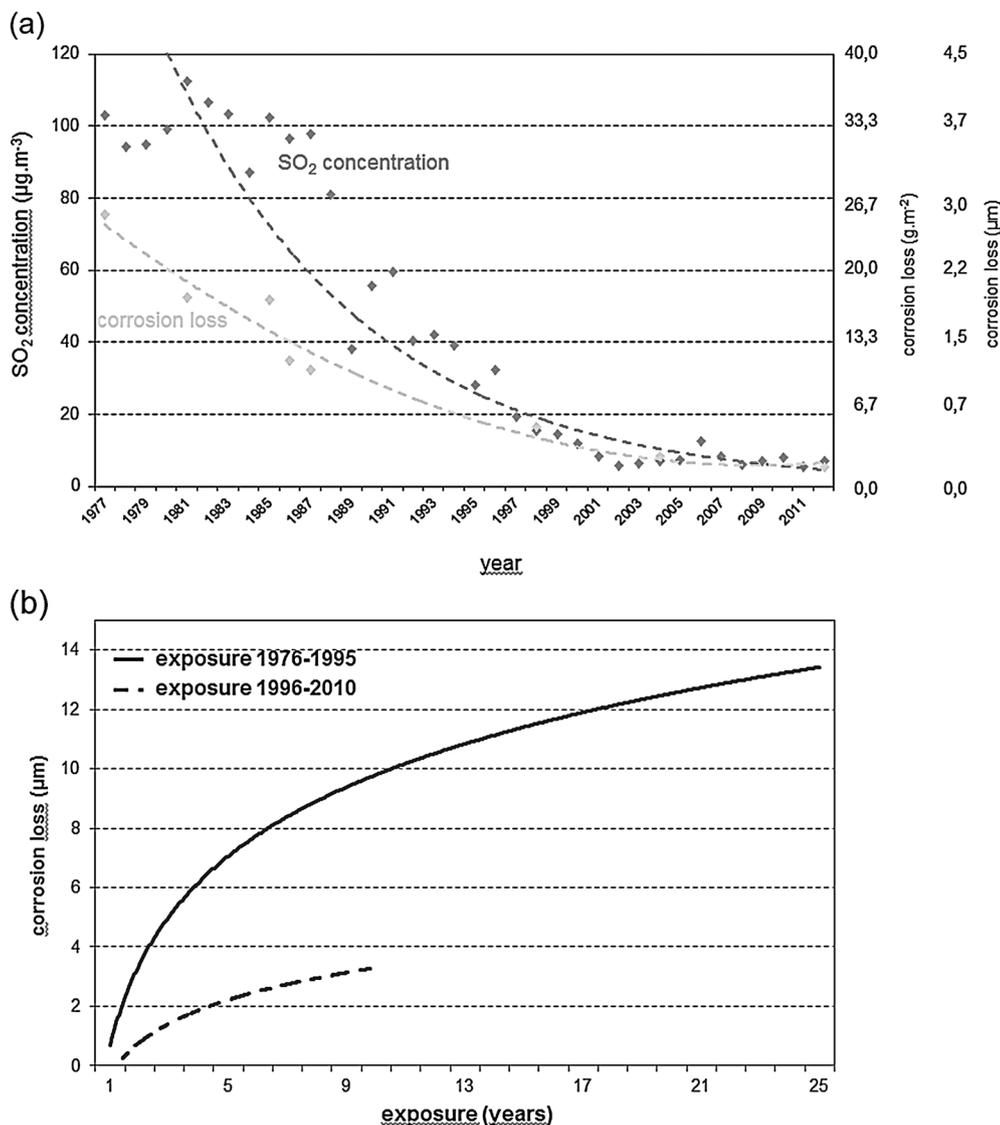
**Figure 4.** Corrosion mass loss of copper over various periods in Prague, Czech Republic; (a) repeated yearly exposure, (b) long-term exposure.

At atmospheric test sites in the Czech Republic the standard copper and bronze samples were exposed as part of national and other international projects. The dependence of the decreasing rate of mass loss of copper on  $\text{SO}_2$  air pollution (steady pollution situation) is illustrated in Figure 4. The actual corrosion rate of

structural metals quickly reacts to decreasing  $\text{SO}_2$ . The surfaces exposed to a highly polluted environment showed a slowing in corrosion rate in case  $\text{SO}_2$  pollution was lower in the atmosphere.

At the Czech test site the copper was exposed for 20 and 25 years, from 1981 to 2006. During this period the yearly value of  $\text{SO}_2$  air pollution decreased from  $145 \mu\text{g}\cdot\text{m}^{-3}$  to  $11 \mu\text{g}\cdot\text{m}^{-3}$  in 2003, respectively  $19 \mu\text{g}\cdot\text{m}^{-3}$  in 2006, while the other environmental parameters were probably stable [10]. The corrosion mass loss fell in the newly exposed samples and the samples exposed to a highly polluted environment showed a slowing in corrosion rate in case  $\text{SO}_2$  pollution had been reduced in the atmosphere – Figure 5. This is very important for predicting the service life of existing structures or objects exposed for centuries to such environmental conditions.

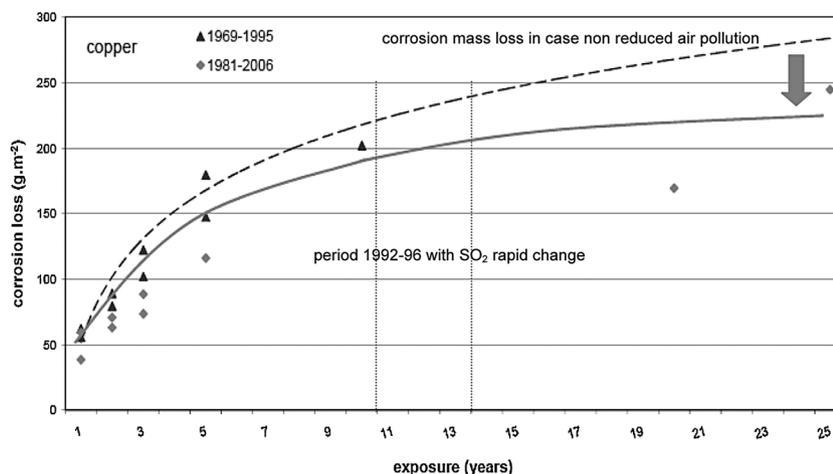
**Figure 5.** Changes in long-term corrosion behaviour of copper in atmosphere with changing corrosivity.

The corrosivity of the atmosphere in the Prague centre where both objects are located was very high in the past due to industrial pollution and emissions from heating. The air  $\text{SO}_2$  pollution in the Prague centre was  $90 \mu\text{g}\cdot\text{m}^{-3}$  in period 1970 - 90 and was about  $15 \mu\text{g}\cdot\text{m}^{-3}$  for the last 20 years [18]. During the 1970s and 1980s, when the air pollution reached its highest concentration, the corrosivity of the atmosphere in the Prague centre fell in category C5 according to EN ISO 9223.

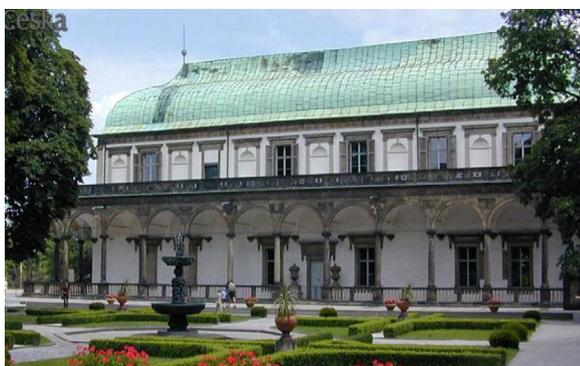
**Figure 6.** View of the west side of the Belveder roof in 2001 (before the first reconstruction).

The original thickness of the copper sheets was about 0.8 mm. The residual thickness after ca. 325 years varies from 0.35 to 0.50 mm in the most affected eastern ridge part. The residue thickness of other, less affected parts is about 0.6 mm. This represents a loss of ca.  $200\text{ }\mu\text{m}$  and degradation rate ca.  $0.6\text{ }\mu\text{m.a}^{-1}$ . This value should correspond to the steady corrosion rate in an atmosphere with corrosivity category C4 for copper according to EN ISO 9224. The highest loss of copper sheet thickness was estimated in the lower part on the west side of the roof, where long-term accumulation of water and deposits and mechanical stress and erosion by wind is expected. The application of best fitting prediction models shows the distribution of copper corrosion loss during this long-term exposure – Table 3. Both prediction models are relatively similar and correspond to the determined average long-term corrosion rate of  $0.7\text{ }\mu\text{m.a}^{-1}$ . The time exponent coefficient applied in both models is too low ( $b = 0.667$  or  $0.835$ ) for this real application of copper sheets. If this coefficient were 1, the total corrosion loss would be ca.  $200\text{ }\mu\text{m}$ , which correspond to the determined value.

The variety of colours and compositions of the patina correspond to the shape arrangement of the roof. The thickness of the patina layer ranged from 7 to  $142\text{ }\mu\text{m}$  with an average value of  $44\text{ }\mu\text{m}$ . The dominant compound in the patina was brochantite ( $\text{Cu}_4(\text{SO}_4)(\text{OH})_6$ ), while other compounds such as cuprite and antlerite were found, too.

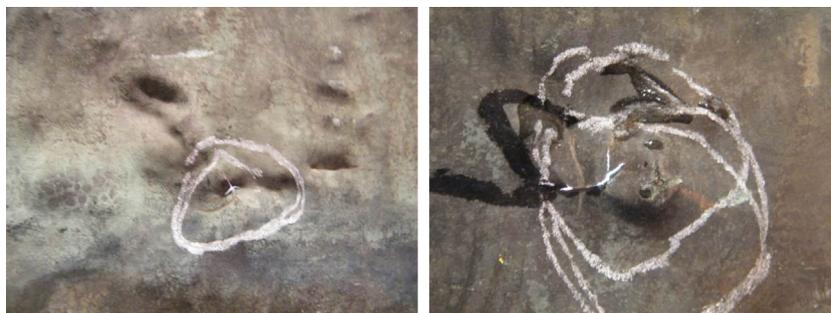
**Figure 7.** Details of roof panels – cracks and penetrations (lower side of copper sheets).

The limiting property for the serviceability of the roof was not corrosion (material) loss but the reduced mechanical properties. The strength  $R_m$  of historic sheet copper was only

156 MPa and the elongation only 10%. As a result of these conditions, there were cracks and perforations in the sheets with the minimum thickness (Figure 7).

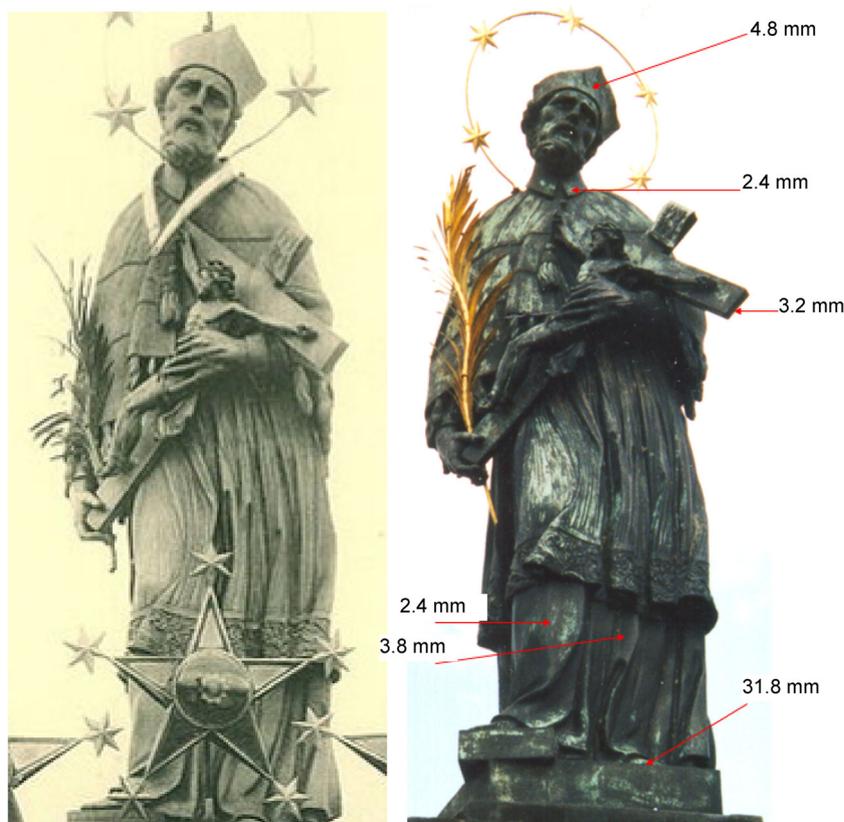
**Figure 8.** St. John of Nepomuk statue on Charles bridge (1910 and 1998) with bronze thickness measuring areas.

There are 30 statues mounted to the balustrade of Charles Bridge in Prague. The statue of St. John of Nepomuk is the oldest on the bridge - the original is from 1683 (Figure 8). The original clay design was made by Austrian sculptor *Matthias Rauchmüller*, based upon a wood model by *Jan Brokoff*. The statue was then cast in bronze by *Volfgang Jeroným Heroldt* in Nuremberg.

In 1996 measuring of the bronze thickness was performed - the minimum value was 2.4 mm and in some areas it was ca. 5.0 mm depending on the design and shape of the statue

(Figure 8). The critical residual thickness for bronze statues was estimated at 2.0 mm.

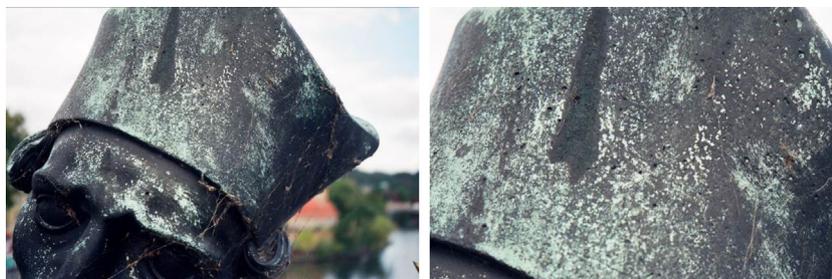
Figure 9. Detail of bronze surface with open holes.

Small holes in the forehead and cap of the statue were recorded in the year 1989 (Figure 9). These defects occurred as a result of corrosion loss of the bronze material in these most exposed areas. From a photo taken in 1910 there is an indication that the cap was gilded and this layer protected the surface of bronze.
