Analysis of mural paintings using *in situ* non-invasive XRF, FTIR spectroscopy and optical microscopy

An analytical protocol consisting of X-ray fluorescence spectroscopy, optical microscopy and Fourier transform infrared spectroscopy was used to study the origin and the nature of the materials (pigments, binders and coating preparation) of the Fundenii Doamnei church mural paint from Bucharest. The main interest of the present study consisted in the original votive paint from narthex, painted in 1757 in a *secco* technique.

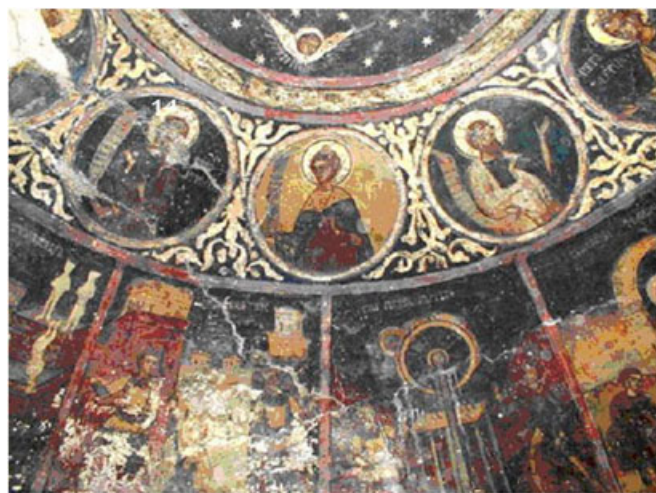
Figure 1. Technique of fresco painting in the 18th century.

The painting was realized by Parvu Mutu, the court painter of the Cantacuzino family. During 1756–1757 the original paint from 1699 was almost removed and the church was repainted (Fig. 1).

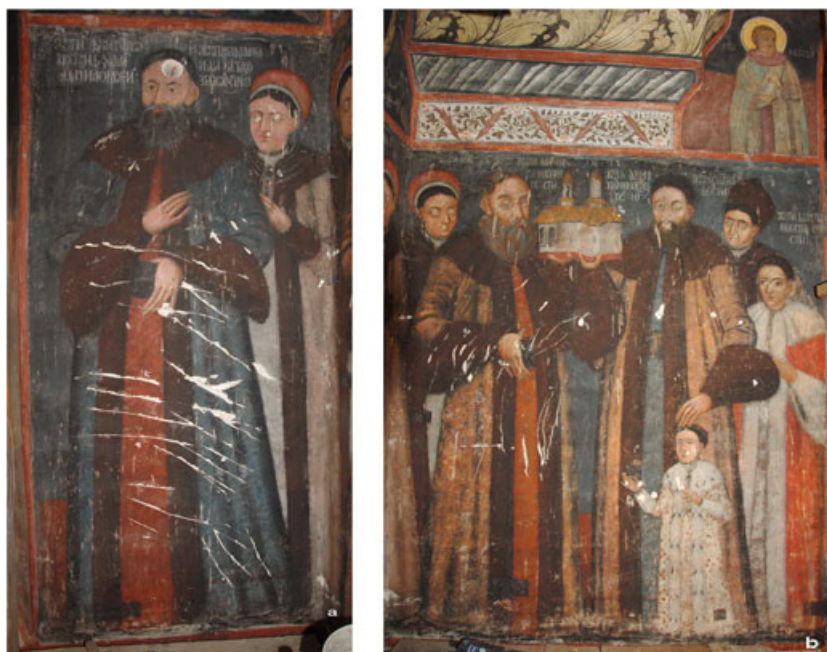
Figure 2. Votive *a secco* painting technique, 1757. (a) Prince Constantin Mavrocordat and his wife Catherine. (b) Racovita Dumitrascu great chancellor, Despa wife and their children, with the analyzed points indicated.

In the votive paint on the western wall (Fig. 2(b)) of the narthex is painted the founder of the second stage (1756–1757), the great chancellor Dumitrascu Racovita with his wife Despa and their children Dumitrascu and Soltana alongside the high steward Mihail Cantanuzino. Continuing, on the southern wall are represented Ilinca Cantacuzino and her husband and on the south-eastern side of the narthex (Fig. 2(a)) is depicted the family of the ruler Constantin Mavrocordat and his wife Ecaterina.

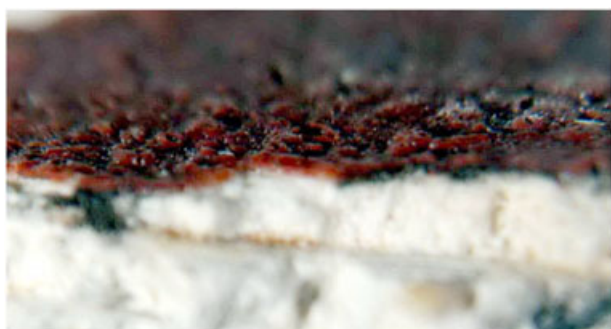
Figure 9. Microphotograph of a polished cross section of sample 9 under reflected visible light: azurite, calcium carbonate and ochre grains (white and ochre layer), 160 \times .

Optical analysis of a cross section of the red pigment sample, which is cinnabar according to XRF analysis, shows that the color layer was applied directly to the substrate that contains voids, quartz particles and blue pigment migrated granules (Figs 8 and 9).

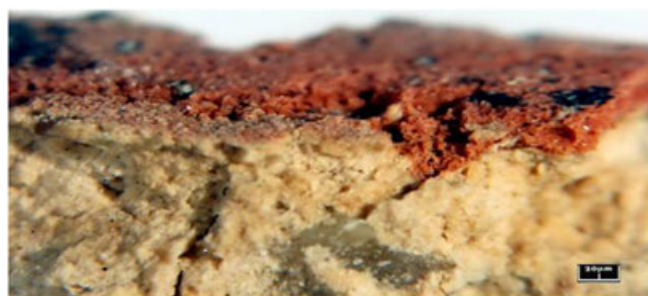
Figure 10. Microphotograph of a polished cross section of sample original painting age 1699: cinnabar, calcium carbonate and quartz crystals, 160 \times .

As for azurite blue pigment, granules penetration in lime mortar indicated that the paint must have been applied on a wet mortar (Fig. 7). In thin sections, the pigment particles are often randomly oriented in the paint layer (Fig. 10).
