Journal of Cultural Heritage xxx (2014) xxx-xxx

Case study

Structural characterization of corrosion product layers on archaeological iron artifacts from Vigna Nuova, Crotone (Italy)

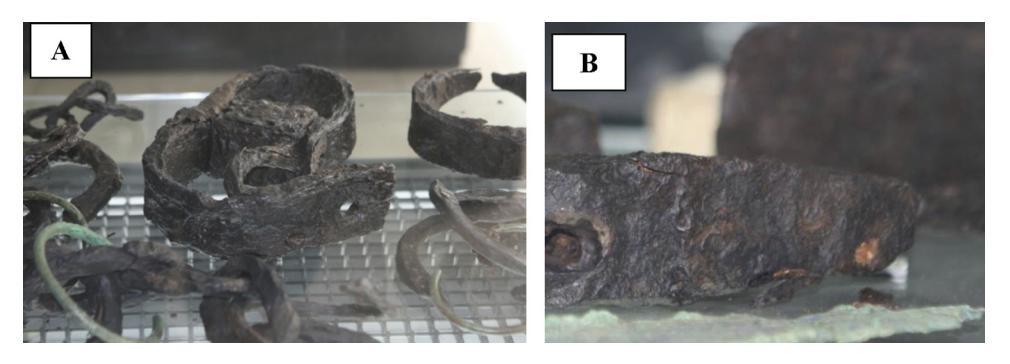
Fig. 1. A. and B. Archaeological iron artifacts coming from Vigna Nuova (Calabria, Italy) with flaking phenomena.

A collection of archaeological iron artifacts including agricultural implements, chains, arrowheads (Fig. 1A and B), from the archaeological site of "Vigna Nuova" in Crotone (Calabria, Italy), and kept at the Archaeological National Museum of Crotone (Calabria, Italy), were investigated.

Archaeological artifacts show evident rust patina and they are characterized by metallic layer exfoliation (flaking). A total of

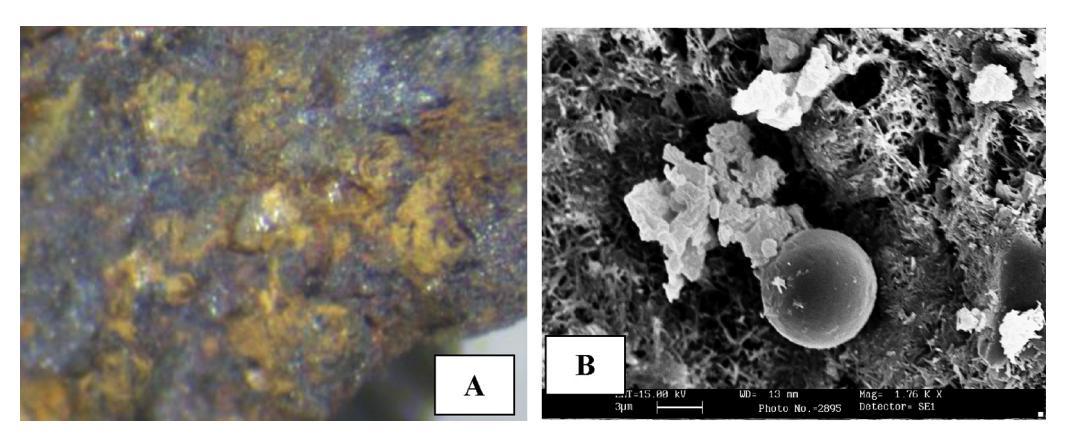
Fig. 2. A. Stereomicroscope picture showing hollow shells characteristic of weeping. B. SEM microphotographs made on iron surface showing typical weeping hallow shells.

Inner corrosion layer is the most corroded. It is characterized by two typical signs of active corrosion: "weeping" (the beads of liquid) and the presence of a compact reddish-brown or bright orange corrosion. The term "weeping" is used by archaeologists to describe the formation of 'tears' or 'sweat' on the surface of excavated iron due to the hygroscopic nature of iron chloride salts [4]. The phenomenon of "weeping" has been ascertained on the surface both by stereomicroscope through the hollow shells characteristic of weeping iron (Fig. 2A) [5] and by SEM morphological analysis. Fig. 2B shows typical weeping hallow shells [6]. The formation of these shells can be explained as a result of the oxidation and hydrolysis of Fe²⁺ ions or the hydrolysis of Fe³⁺ ions and the precipitation of FeOOH in the liquid drops. The compact yellow to dark brown layer of corrosion on the surface of most of the iron samples is composed mainly of lepidocrocite, γ -FeOOH; akaganeite, β -FeOOH and hematite, α -Fe₂O₃ as revealed μ -Raman Spectroscopy analysis (Fig. 3). Moreover, the presence of these corrosion products was confirmed by XRD (Supplementary material, Fig. S1). External rust powder was analyzed by ATR [7-9] and akaganeite was the main product. The spectrum shows strong maxima absorption at 644, 852, 1652, and 3328 cm⁻¹ indicating the presence of akaganeite (β -FeOOH), while the major features at 1652 and 3328 cm⁻¹ represents the H-O-H fundamental bending and stretching modes [10].

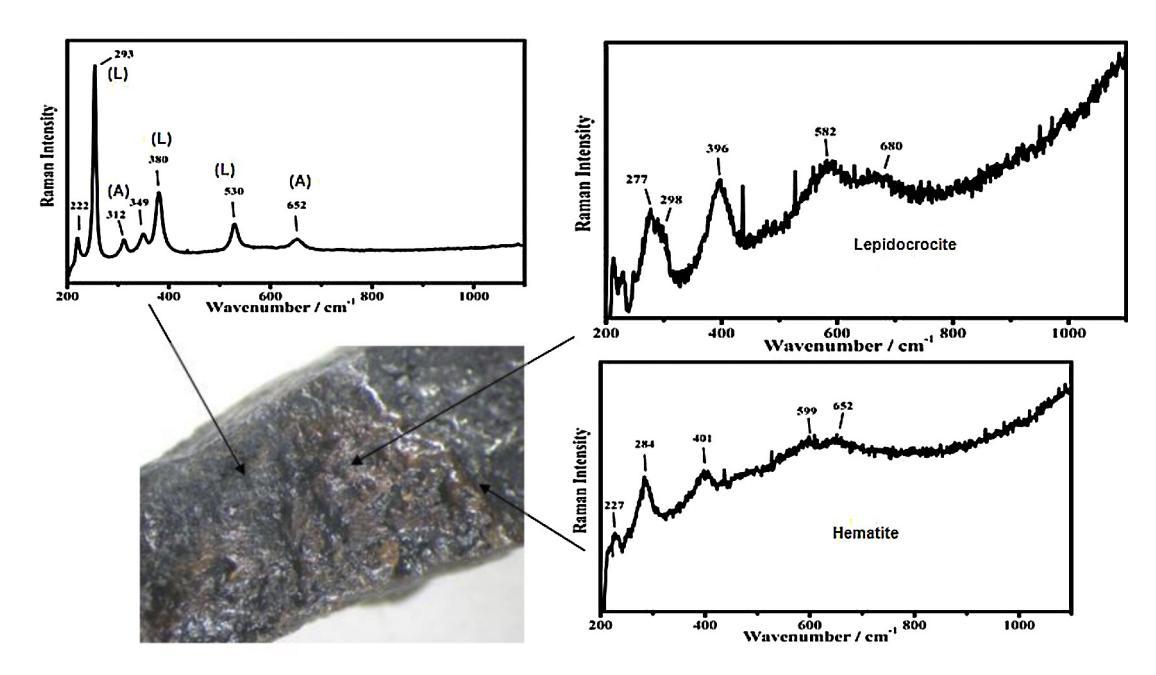
Fig. 3. Inner corrosion layer's surface analyzed by μ -Raman Spectroscopy and some of Raman spectra of Lepidocrocite (L), Akaganeite (A) and Hematite.

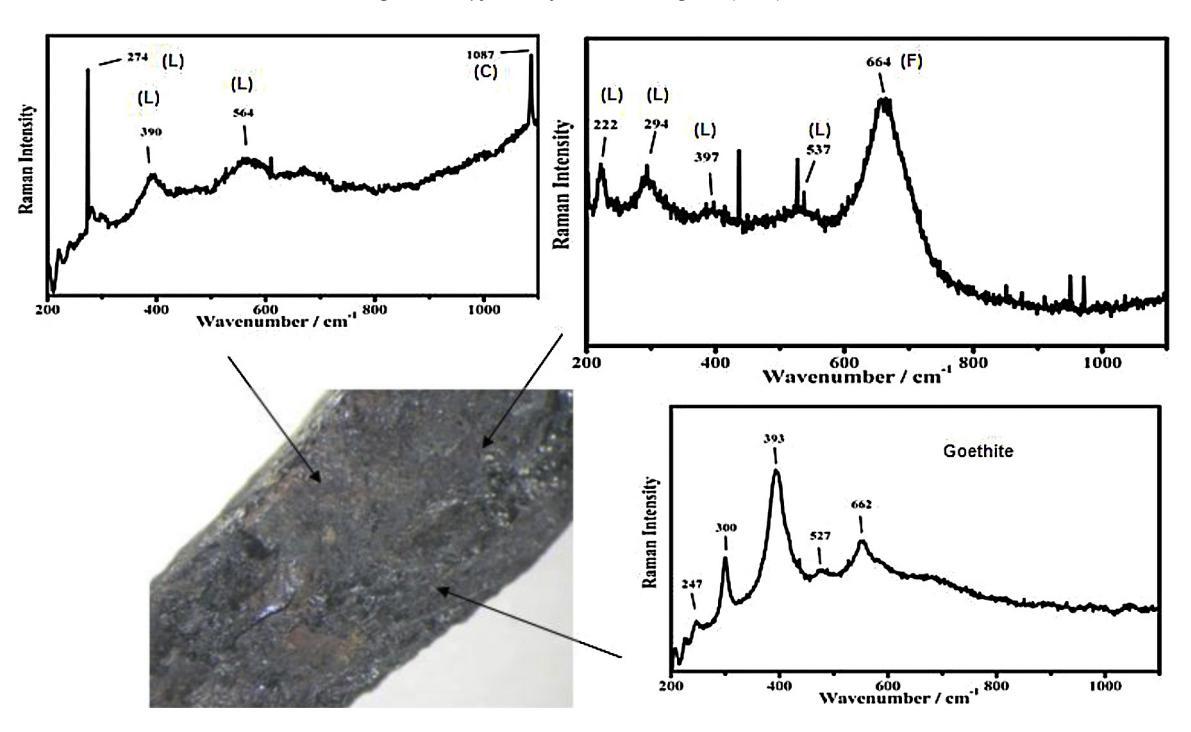
Fig. 4. Outer surface analyzed by μ -Raman Spectroscopy and some of Raman spectra of Lepidocrocite (L), Calcite (C), Ferrihydrite (F) and Goethite.

Outer surface is more preserved than the inner corrosion layer's surface. In fact, there are no signs of exfoliations, cracking or orange pitting. According to μ -Raman Spectroscopy (Fig. 4), this face is characterized by the presence of lepidocrocite, goethite and ferrihydrite (δ -FeOOH spectrum confirmed broad bands, due to its low crystallinity, around 664 cm⁻¹ and a weaker one at 397 cm⁻¹). The peak at 1087 cm⁻¹ is assigned to calcite (CaCO₃). The ATR spectrum (data not shown) shows the presence of γ -FeOOH, α -FeOOH and Fe₃O₄ which is confirmed by the appearance of peaks at 1051 cm⁻¹ (lepidocrocite), 894 cm⁻¹, (goethite) and 580 cm⁻¹ (magnetite) [11]. Moreover, the ATR analysis shows the presence of δ -FeOOH (ferrihydrite) as the major component of rust since the
