# Raman spectroscopy in the diagnosis of the wall painting *History of Concepción*, Chile

# T. Aguayo,<sup>a</sup> E. Clavijo,<sup>a</sup> F. Eisner,<sup>b</sup> C. Ossa-Izquierdo<sup>b</sup> and M. M. Campos-Vallette<sup>a</sup>\*

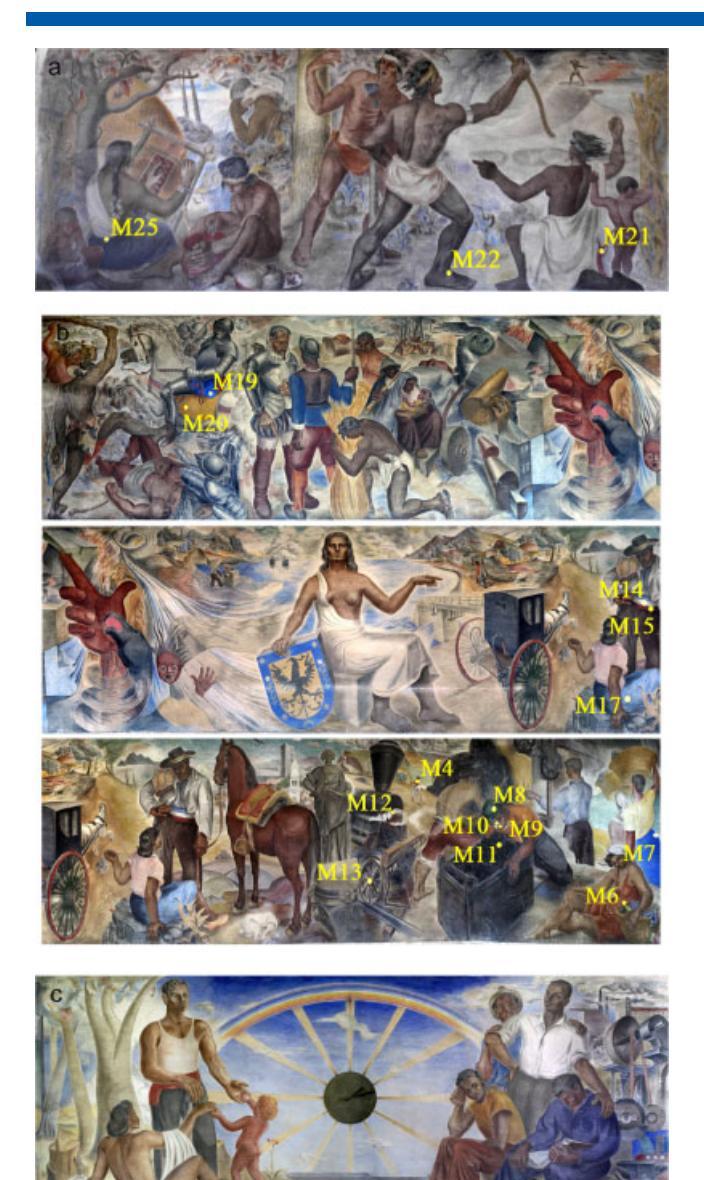
Figure 1. Wall painting *Historia de Concepción*, left (a), central (b) and right wall (c).

Raman microscopy was selected as one of the analytical techniques chosen to analyze different materials related to the wall painting *Historia de Concepción* by Gregorio de la Fuente (1910–1999) (Fig. 1a–c), under the project *Estudio Diagnóstico del*

Brown colors observed (Fig. 1) are produced with hematiteand goethite-containing earth pigments. Earth pigments are commonly mixtures of clay materials with different chromophores such as those found in this case (hematite or goethite).<sup>[28]</sup> Spectra (Fig. S2) obtained from samples M9 and M22 suggest that earth pigments could have been, in some cases, darkened with carbon black.

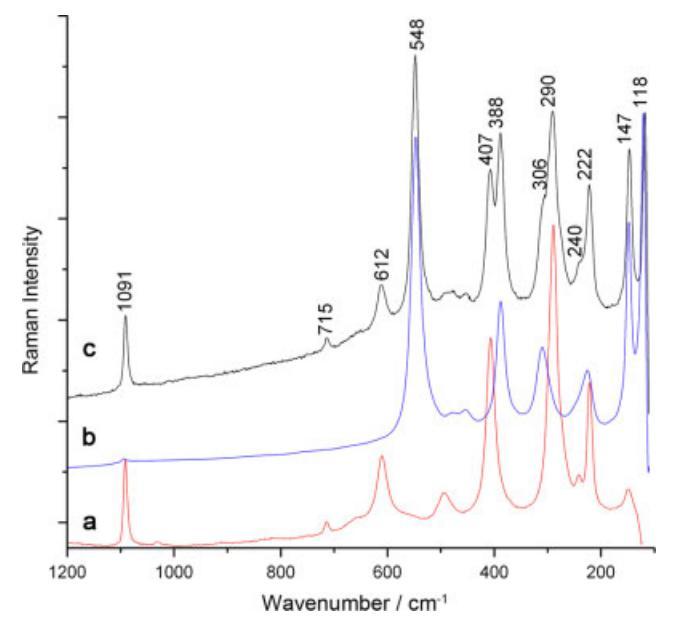
Raman spectroscopy has been used to identify pigment mixtures.<sup>[19-21]</sup> Red samples (Table 1) are mainly iron(III) oxide, also called hematite. Some mixtures of hematite and minium (lead(II,IV) oxide) have been observed (Fig. 2), and are recognized by the characteristic Raman bands of Fe(III) and Pb(II,IV) oxides. Hematite stretching bands corresponding to the Fe-O bond are observed at 222 and 494 cm<sup>-1[22]</sup>; the deformation modes are assigned to the bands at 240, 290, 407, and 612 cm<sup>-1</sup>, following Legodi et al.<sup>[23]</sup> The Pb(IV)–O stretching mode is observed at 548 cm<sup>-1</sup>, while the O-Pb(IV)-O deformation mode corresponds to the band at  $118 \text{ cm}^{-1}$ ; the stretching Pb(II)–O is ascribed to the band at  $147 \text{ cm}^{-1}$ , in agreement with Bussotti *et al.*<sup>[24]</sup> It has been shown that minium should not be used for the fresco technique,<sup>[25]</sup> as dismutation reactions occur in acid and alkali media,<sup>[26]</sup> producing PbO<sub>2</sub> (plattnerite). Here, PbO<sub>2</sub> was not detected spectroscopically. Fortunately, hematite, which is highly compatible with any binder and largely used in all kinds of paintings, does not display collateral reactions in the present artwork (collateral reactions as those concerning blackening process<sup>[27]</sup> or those mentioned above for minium). On the basis of XRF data, it can be proposed that iron-containing molecular species are the ones mainly responsible of the red color in areas from where no

Figure 2. Raman spectra of iron(III) oxide (a), lead (II,IV)oxide (b), and their mixture (c), found on red samples.

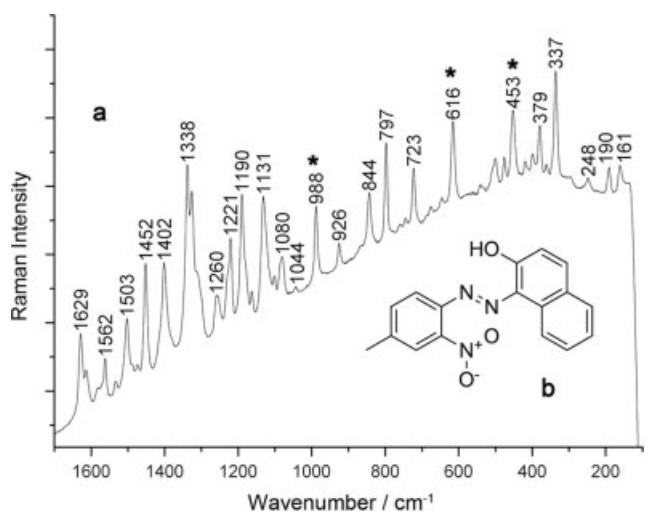
Toluidine red (PR3), an organic red pigment,<sup>[28]</sup> was identified by Raman spectroscopy<sup>[11]</sup> (Fig. 3). According to general vibrational charts,<sup>[29,30]</sup> bands at 1629 and 1503 cm<sup>-1</sup> are assigned to spectral modes of the NO<sub>2</sub> group and aromatic CC stretching. The band at 1452 cm<sup>-1</sup> is unambiguously ascribed to a CH<sub>3</sub> deformation mode. The N=N bond displays its band at 1402 cm<sup>-1</sup>. The strong bands at 1338 and 1325 cm<sup>-1</sup> are assigned to the asymmetric and symmetric stretching modes of the nitro moiety, respectively. Signals at 1221, 1190, and 1131 cm<sup>-1</sup> correspond to CH aromatic

**Figure 3.** Raman spectrum of sample M15 (a) and toluidine red structure (b). The marked bands are ascribed to barium sulfate.

deformation modes. The corresponding out-of-plane modes are assigned to bands at 1080, 844, 797, and 723 cm<sup>-1</sup>. Bands lower than 500 cm<sup>-1</sup> are in general difficult to assign; we propose that the bands at 379 and 337 cm<sup>-1</sup> are due to skeletal ring modes. Thus, the performed spectral assignment confirms the presence of toluidine red. The bands at 988, 616, and 453 cm<sup>-1</sup> are due to the barium sulfate used as filler in this pigment.<sup>[11]</sup>

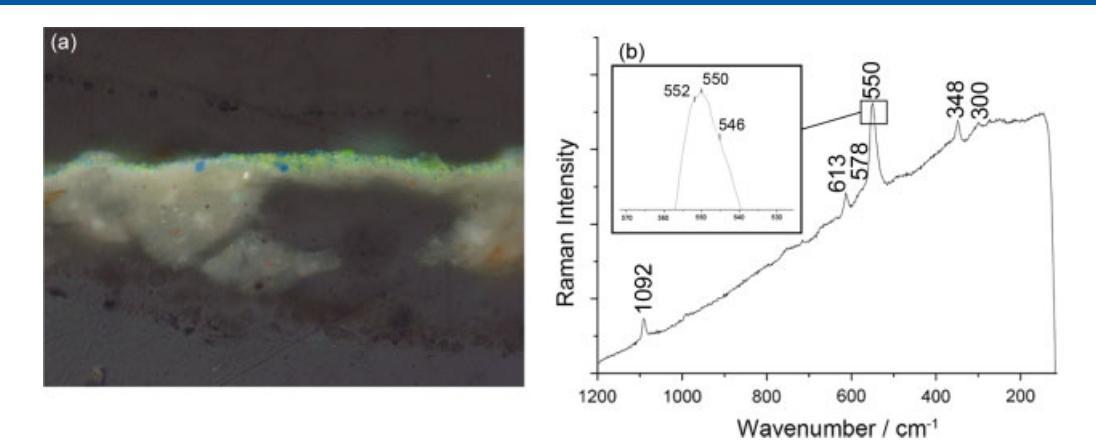
Figure 4. Polished cross-section (a) and Raman spectrum (b) of sample M8.

The green pigment mixed with small amounts of ultramarine blue can be observed from a polished cross-section of the sample (Fig. 4a). The green color is due to the chromium(III) oxide (Cr<sub>2</sub>O<sub>3</sub>), the main green chromophore in this fresco. The asymmetry of the Raman band (Fig. 4b) observed at 550 cm<sup>-1</sup> shows contributions from both lazurite (at ~547 cm<sup>-1</sup>) and the chrome green ( $A_{1g}$ band at ~552 cm<sup>-1</sup>). The band at 348 cm<sup>-1</sup> belongs to the  $E_g$ symmetry species.<sup>[37,38]</sup> Additionally, another green compound was observed in this sample as well as on the blue samples M7, M13, and M17; this compound matches with the one found in a pot in the studio of the artist and its identification is discussed below.

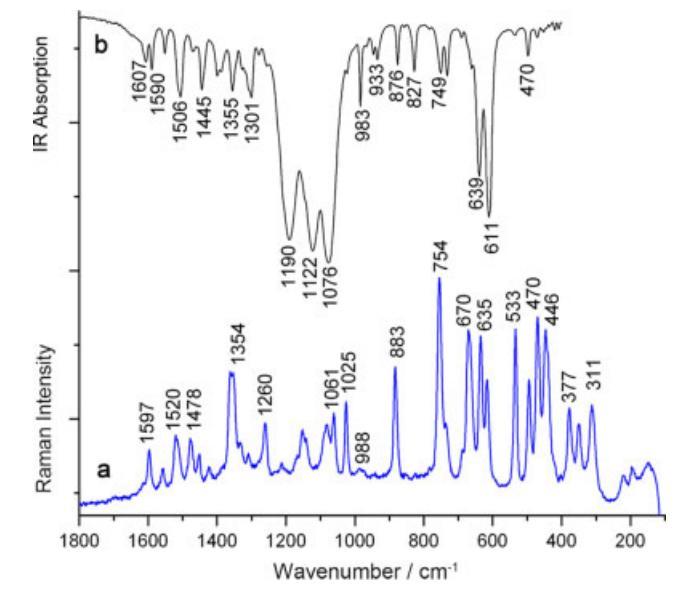
Figure 5. Raman (a) and infrared (b) spectra of pigment 16 collected from the artist's studio.
