Hi-tech restoration by two-steps biocleaning process of *Triumph of Death* fresco at the Camposanto Monumental Cemetery (Pisa, Italy)

Aims: In this work, the 'hi-tech' complex biocleaning and restoration of the 14th-century fresco *Triumph of Death* $(5.6 \times 15.0 \text{ m})$ at the Camposanto Monumental Cemetery (Pisa, Italy) is reported.

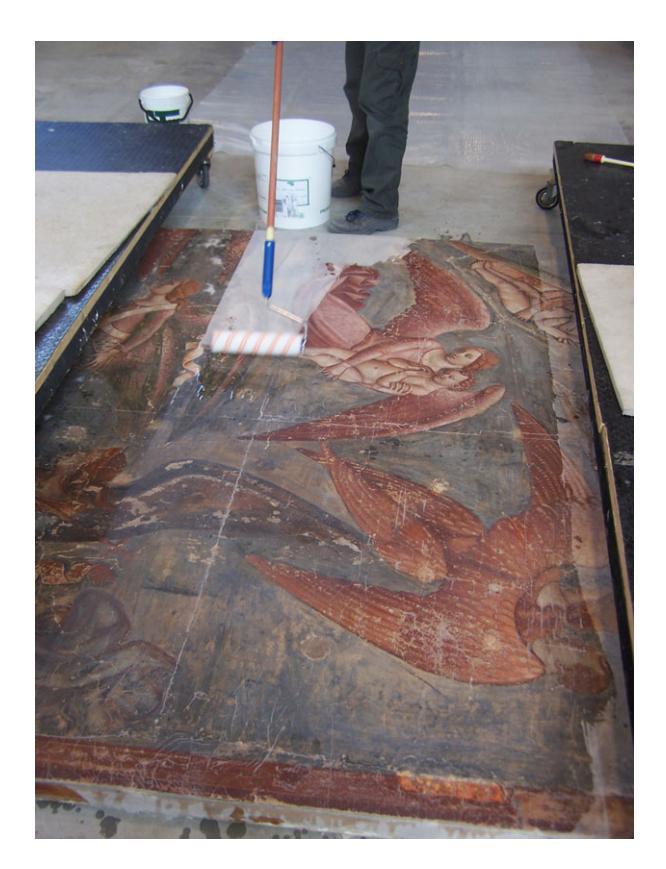
Figure 1 Biocleaning one-step on the front surface of 'Triumph of Death' fresco altered by animal glue residues. [Colour figure can be viewed at wileyonlinelibrary.com]

The *ex situ* biorestoration treatments were performed by a two-steps application (front and back) of the *P. stutzeri* strain A29 bacterial suspension on the altered fresco as indicated in Materials and Methods section (Fig. 1).

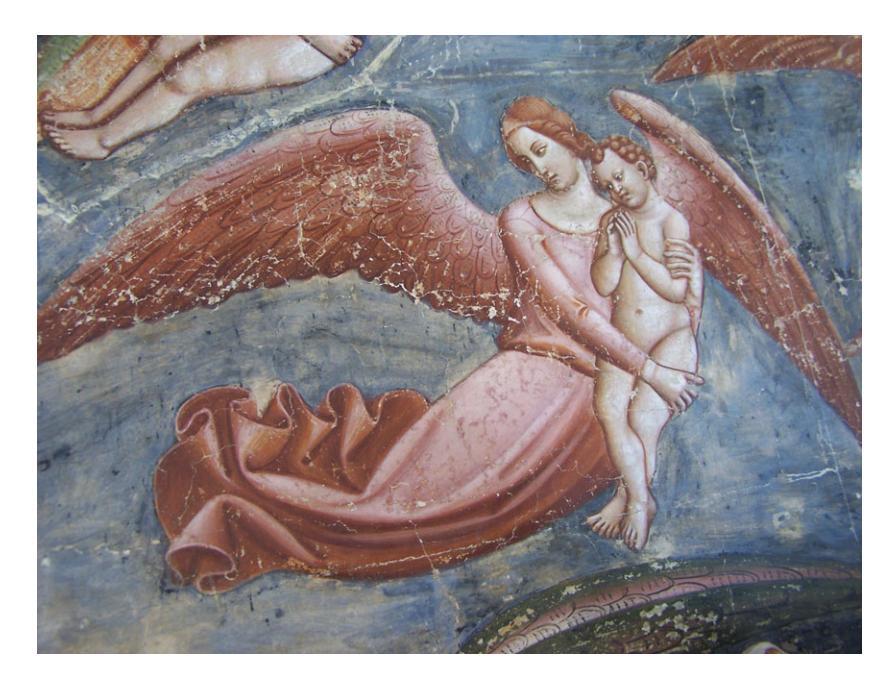
Figure 2 Particular of 'Triumph of Death' fresco surface after the one-step biocleaning. [Colour figure can be viewed at wileyonlinelibrary.com]

After 3 h of biotreatment using bacterial suspension F (at the front of the fresco) and B (at the back of the fresco), the bacterial activity was so intense that the treated areas were largely biocleaned and no residues of proteinaceous materials were presence. The treatment was soft and delicate and did not show any structural damage (Fig. 2).

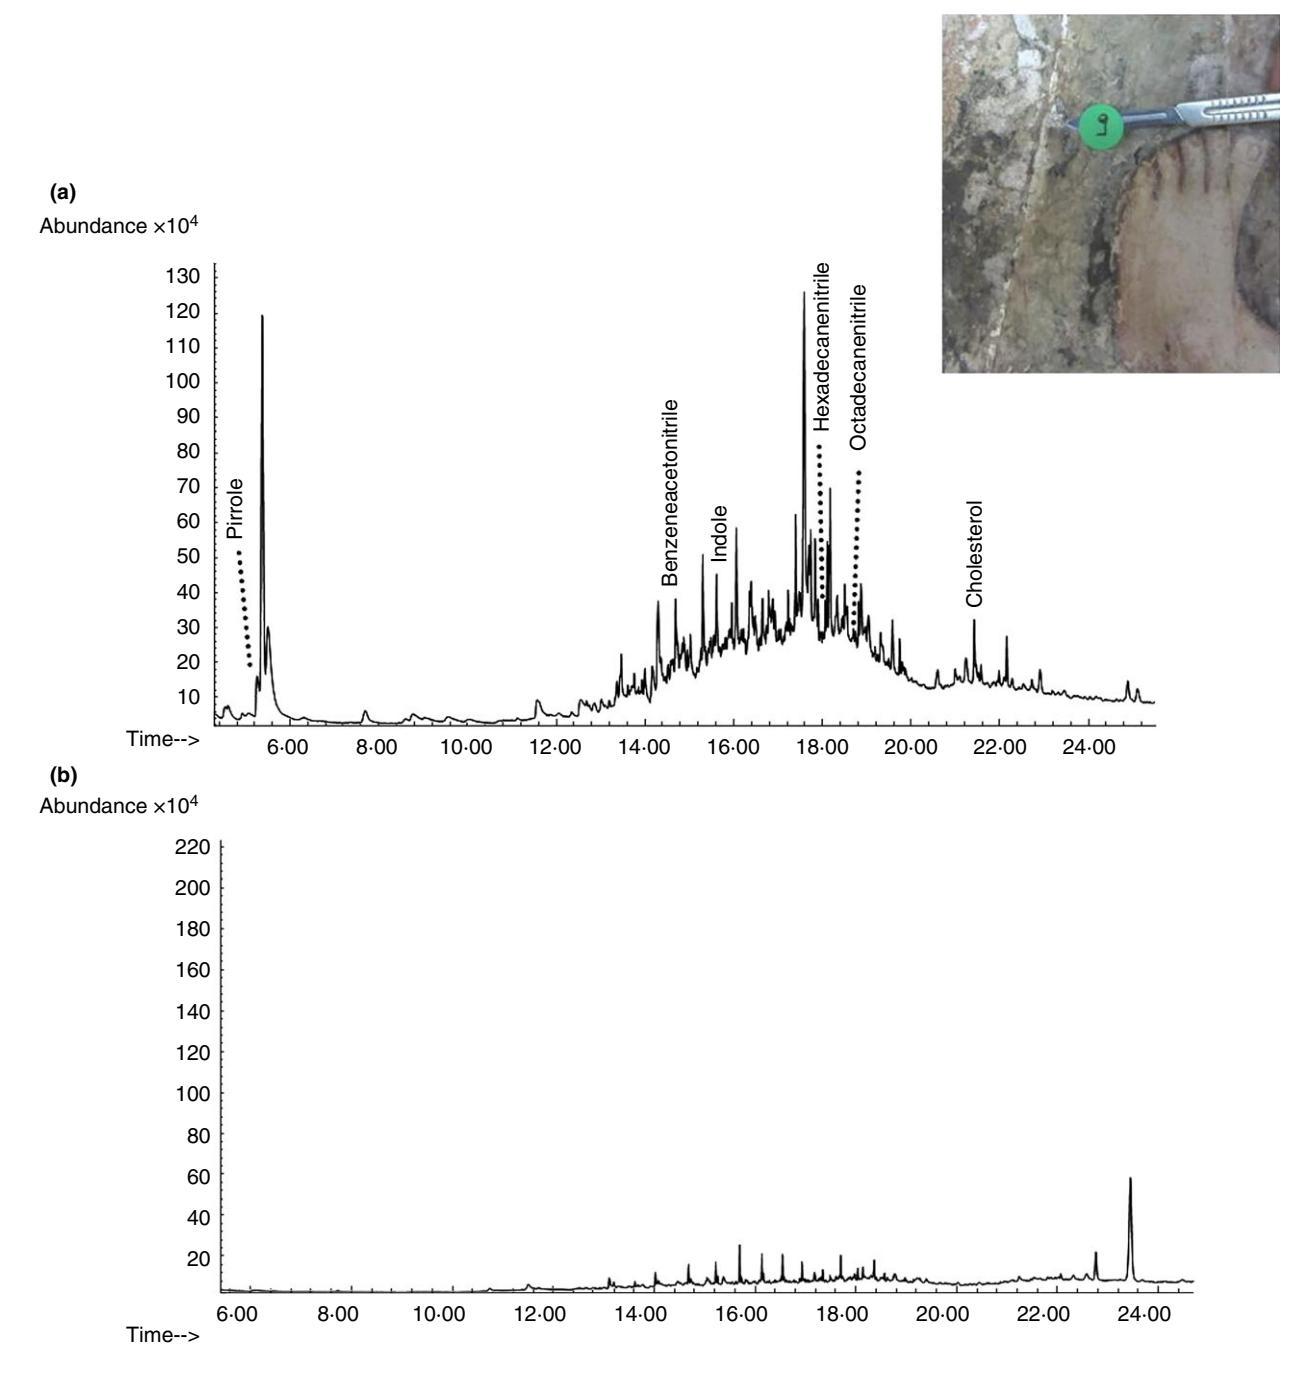
Figure 3 Pyrogram of a sample from *Triumph of Death* front fresco surface with the specific markers identified for each protein (benzeneacetonitrile and indole for casein, pyrrole for animal glue, and hexadecanenitrile, octadecanenitrile and cholesterol for egg). [Colour figure can be viewed at wileyonlinelibrary.com]

The analyses by GC-MS and PY/GC-MS techniques evidenced the presence of proteinaceous material, mainly animal glue, used in the past to glue the gauze onto the front of the fresco (strappo technique) and casein from the calcium caseinate used on the back of the painting. In a few samples in which the paint layer was most abundant respect to the overlaying patina, egg was also present, suggesting his use as organic binder of a few details of the fresco or in the retouching. Fig. 3a shows the pyrogram of one of the samples, with the specific markers identified for each protein. Benzeneacetonitrile and indole for casein, pyrrole for animal glue, and hexadecanenitrile, octadecanenitrile and cholesterol for egg (other peaks in the pyrogram are not labelled for simplicity, but they are typical rearrangement products of the pyrolysis of these proteinaceous materials). Finally, the GC-MS amino acidic profiles confirmed that all the proteins had undergone degradation. After 3 h of biotreatment with bacterial cells suspension F and three gently manual washing steps, the proteinaceous materials were bio-dissolved and not more detectable since below the instrumental limit and sensitivity of the method adopted (see the absence of the main markers of proteinaceous material (Fig. 3b).

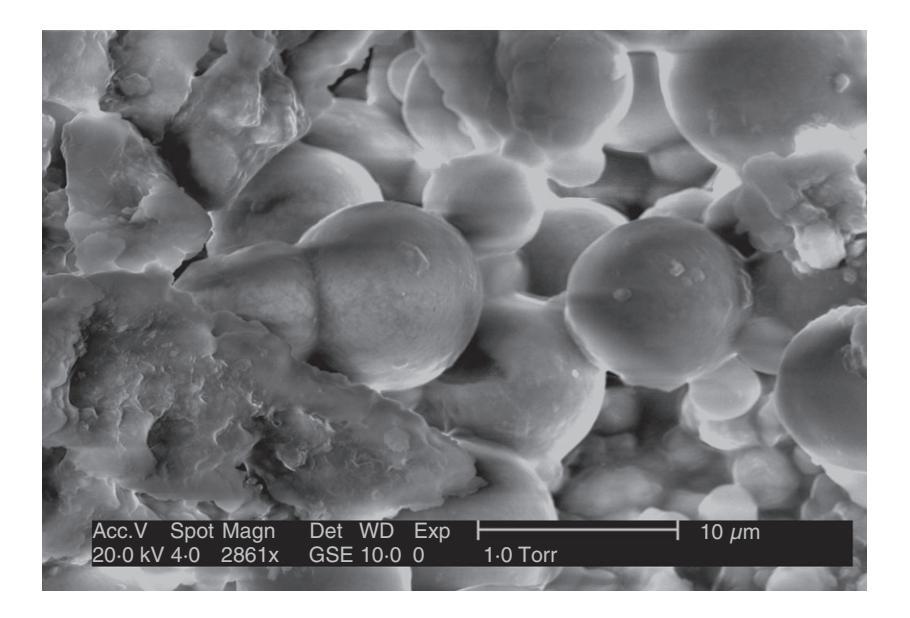
Figure 4 SEM image of a representative sample from the front fresco after the biocleaning and the anionic resin treatment (bar = 10 μ m).

As already indicated in Materials and Methods section, at the end of the restoration, the front fresco surface was treated with anionic resin to remove traces of organic residues. Some representative microsamples from the fresco were observed by SEM, at higher magnifications, and confirmed the absence of micro-organisms after the treatment with the anionic resin and the large presence of spherical particles. In fact, as we observed from the low-magnification picture (Fig. 4), spherical particles were detected with the diameter-around 10 μ m; the same morphology has been previously reported in literature in SEM analyses of anionic resins similar to those used at the end of the restoration work (Gupta *et al.* 2006; Albuszis *et al.* 2016).

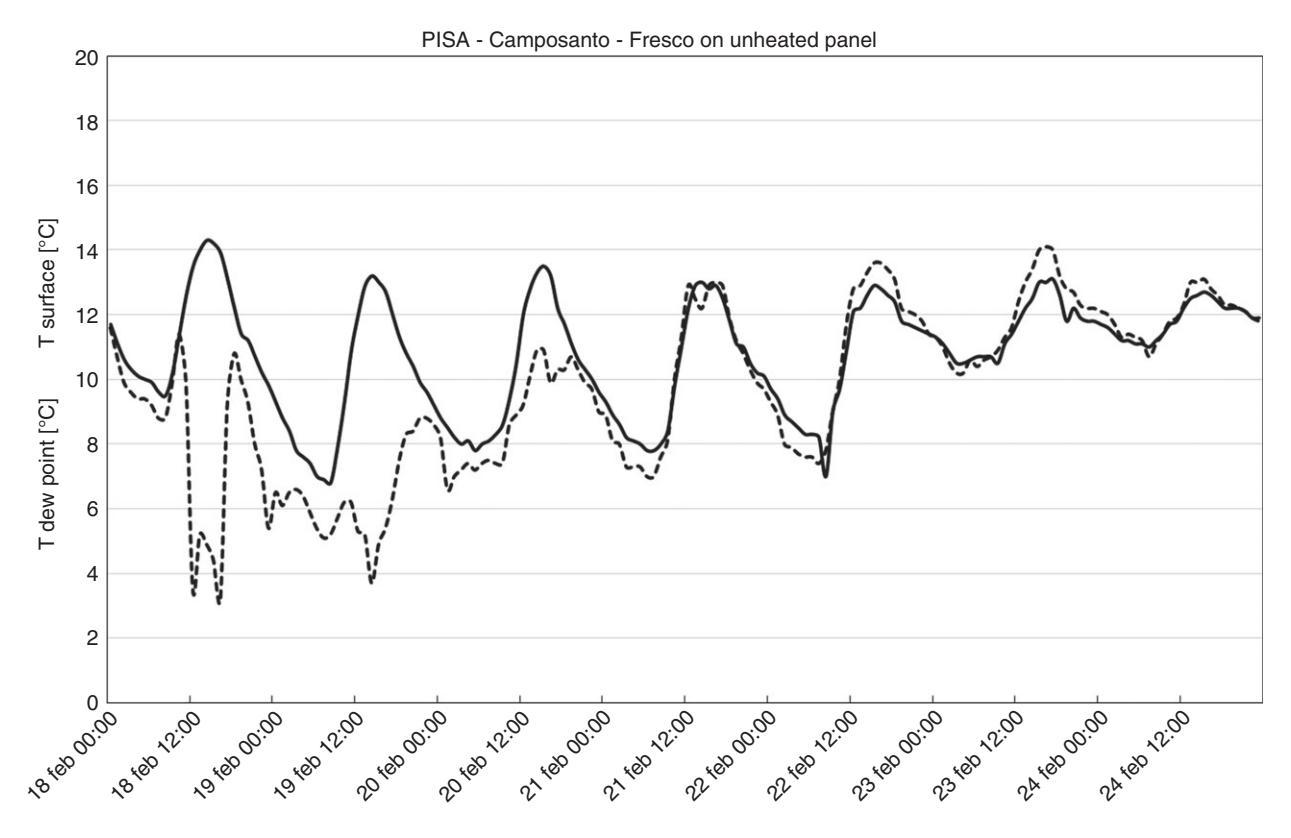
Figure 6 Fresco on unheated panel. The vapor condensation conditions occur when the dew point temperature (dots) exceeds the fresco surface temperature (solid). Condensation events on 22 to 24 February 2017.

The charts (Figs 6 and 7) show the frescoes surface temperature T_s and the dew point temperature T_d . The vapour condensation conditions occur when the dots/yellow curve (T_d) exceeds the solid/green curve (T_s). The unheated panel shows the condensation conditions during the same period. The variation in surface temperature between heating power-on and off is about 2.5°C.

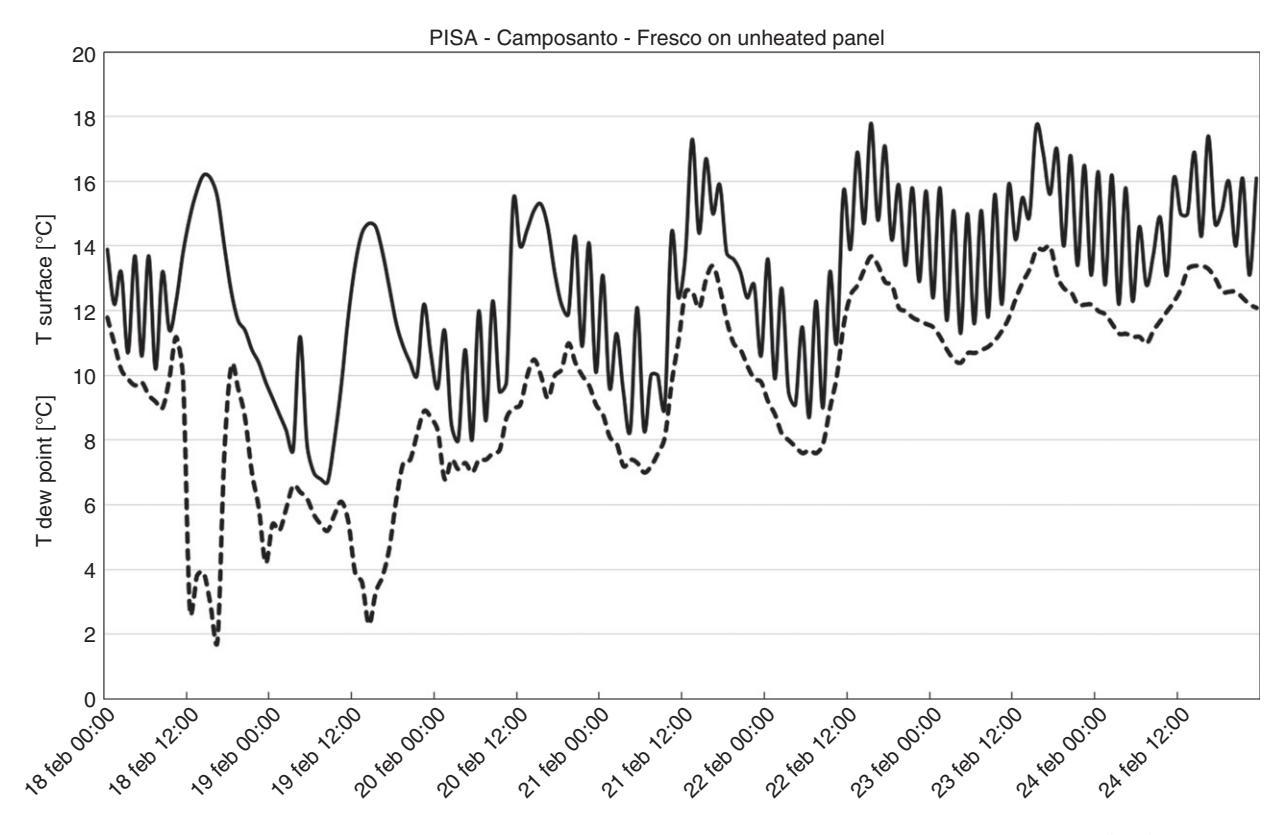
Figure 7 Fresco protected with heated panel. The vapor condensation conditions occur when the dew point temperature (dots) exceeds the fresco surface temperature (solid).
